# Bungambrawatha Creek Line Assessment

FINAL REPORT

January 2023

This report has been prepared by Alluvium Consulting Australia Pty Ltd for the City of Albury under the contract titled 'Bungambrawatha Creek Line Assessment'.

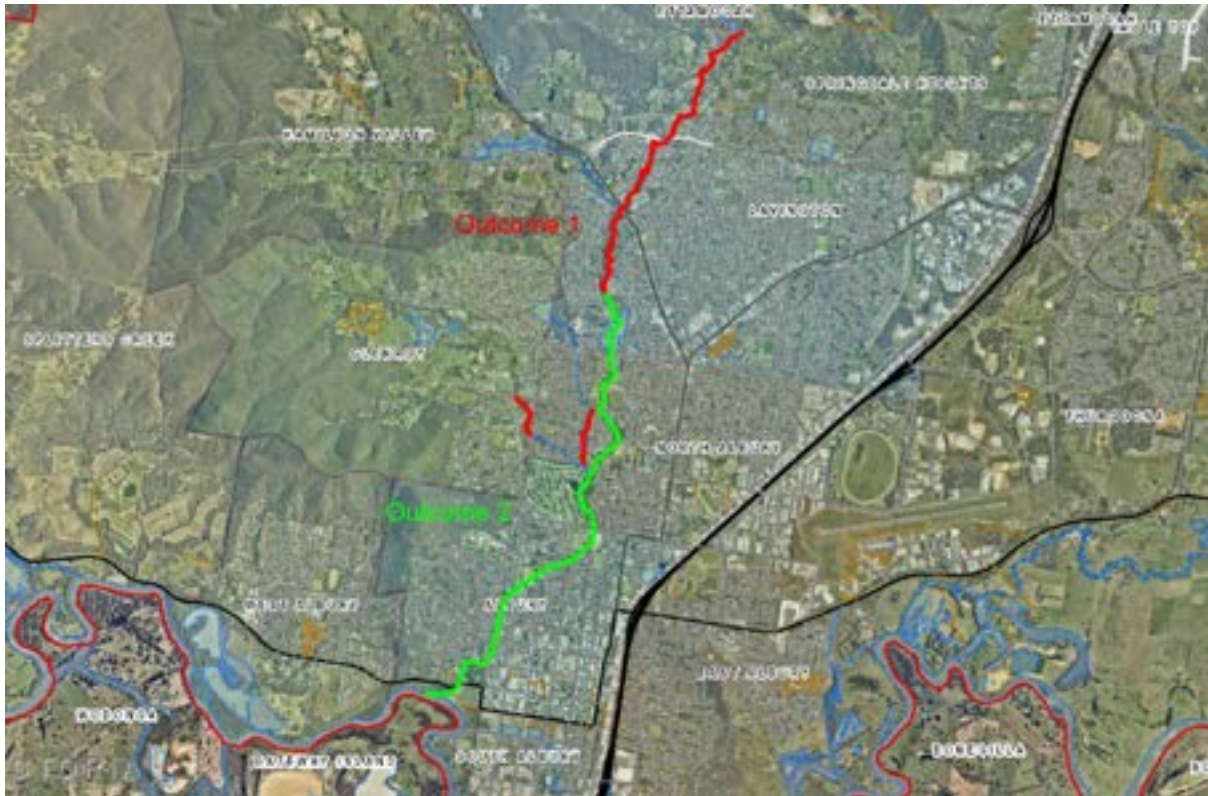
Figure 1 below details the investigation area as it pertains to each individual outcome.

**Figure 1.** Study area for the Bungambrawatha Creek assessment

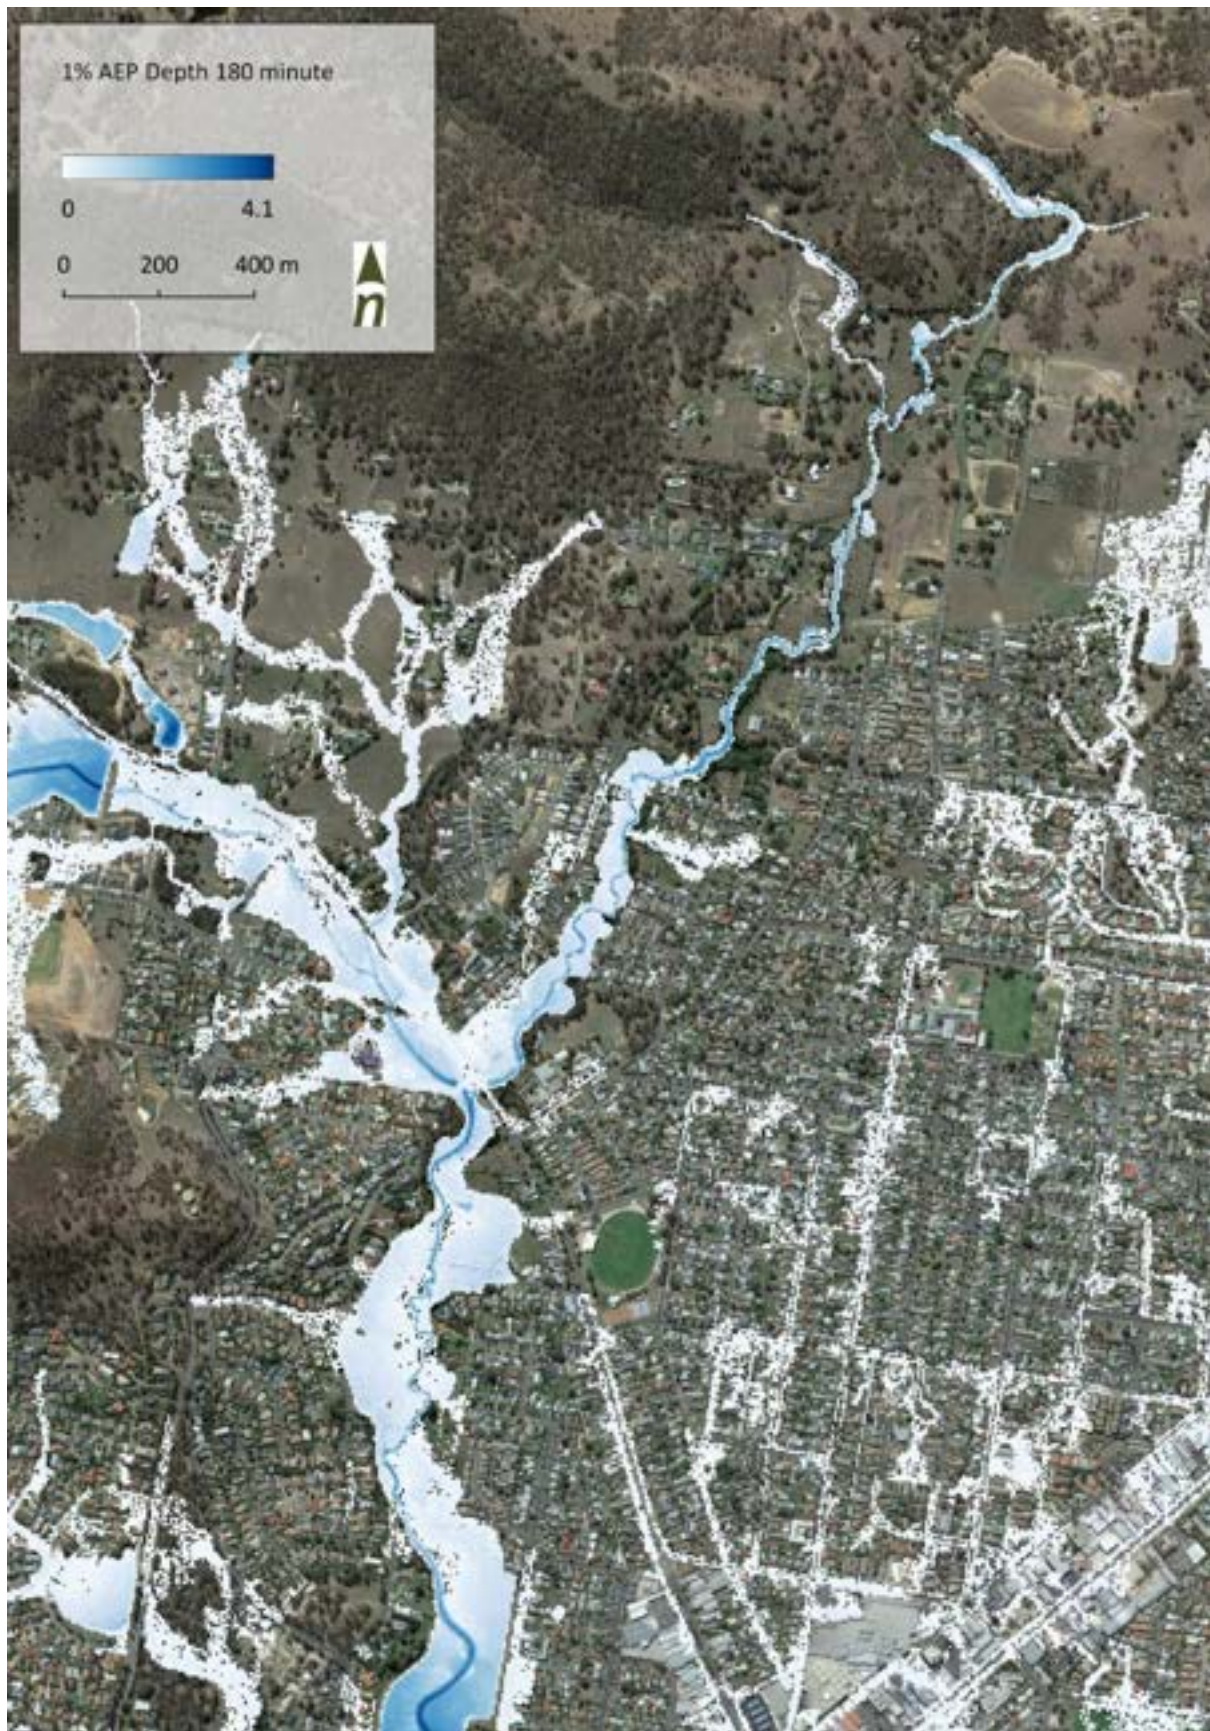
**Figure 6.** 1% AEP flood depth for the critical duration storm - upper Bungambrawatha Creek.

Velocities in the channel are very high courtesy of the highly efficient flow mechanism. Velocities in the 20% AEP exceed up to 5m per second in places, and over 7m/sec in the 1% AEP, presenting a significant challenge to the naturalisation of the channel in these highly confined reaches. It should be noted that these are peak velocities, and refined modelling will be required to determine actual velocities and shear stresses through the channel under a modified scenario.

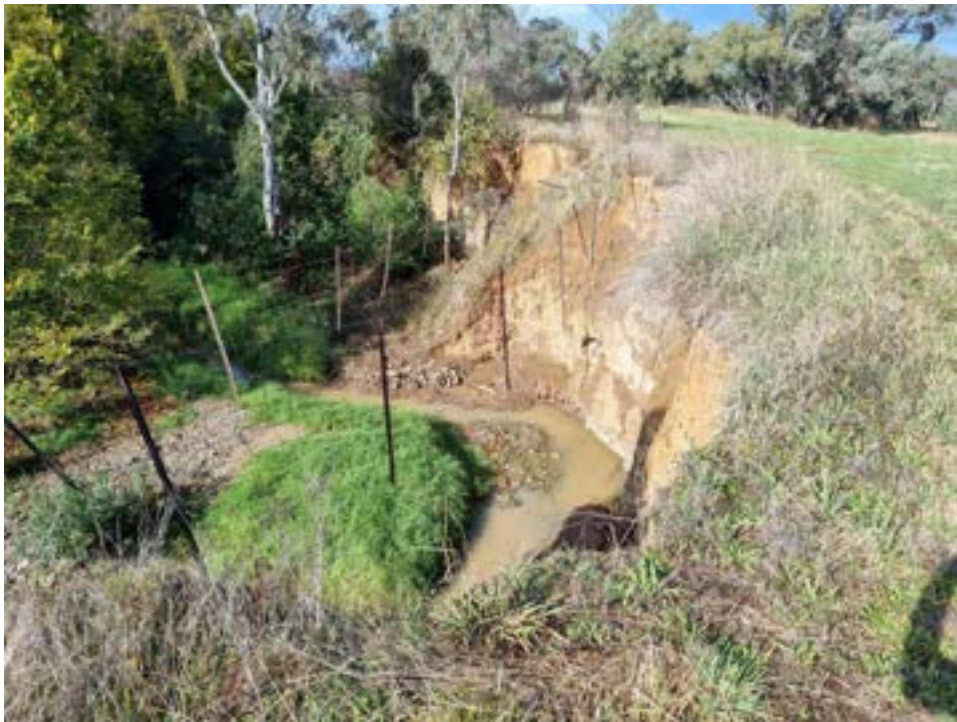
The channel veers away from Prune St at a relatively consistent grade. There is limited sign of bed incision and channel deepening through the main channel, however some very steep banks are migrating laterally at a rapid rate, as evidenced by numerous fence lines being re-erected at the top of bank (Figure 13). Much of the channel adjustment in this area is historic as indicated by large trees present along some of the eroded channel features, floodplain bars and channel boundaries that would be likely to have formed following initial clearing of the catchment.

**Figure 13.** *Migrating channel, with movement noted by the location of old fences.*

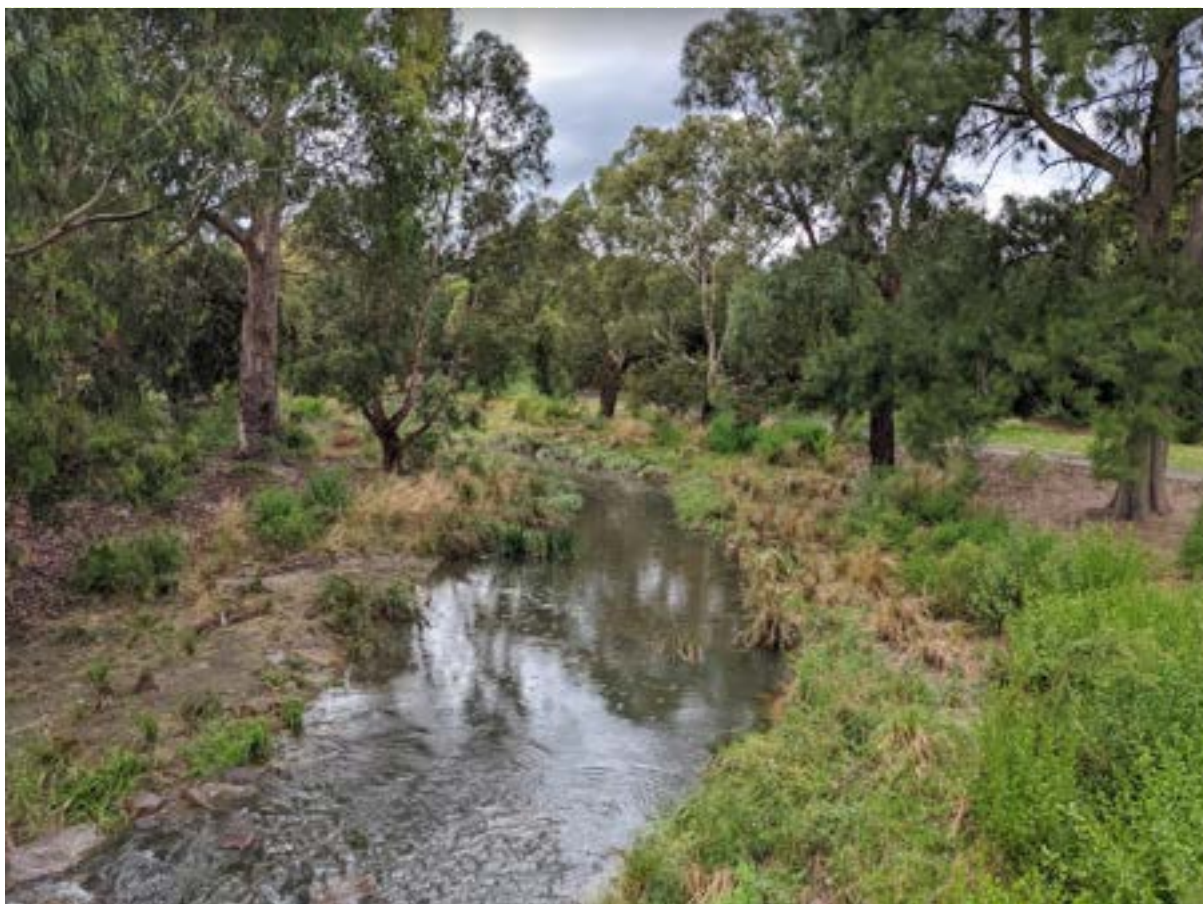
**Figure 14.** *The recently naturalised Blind Creek in Melbourne has many characteristics of a natural waterway, including rocks, grasses and sedges, and large trees (Image: Alluvium)*
